Evaluation of Housing Product Quality Using Six Sigma Approach

Keywords—*housing product, quality, variation, Six Sigma, CIS, Conquas.*

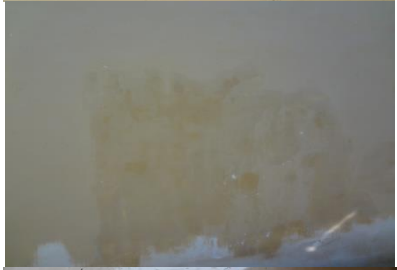
Finishing

problem was the damages of house components like floors, walls, ceilings, doors, and windows. The component damages constituted physical damages. The physical damages could be seen by naked eyes clearly. By CONQUAS, the grouping of damage types was based on architectural viewpoint in internal finishes. The type of damages were floor damages (cracks, uneven plaster, not precise plaster, and sounds hollow), ceiling damages (rift ceiling, poor finishing), wall damages (bad finishing, cracks), door and window damages (do not work, damaged accessories, joint or gap damages). The illustration of the quality variation in the housing is attached in Table 2.

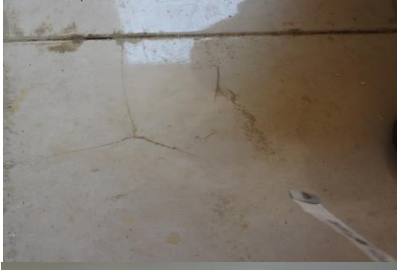
Floor	Crack

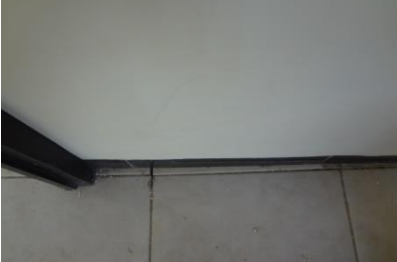
Jointing
